TEST REPORT	
Amendment A to AS/NZS 60598.2.2:2016 Luminaires	
Part 2.2: Particular requirements—Recessed luminaires	
Report reference No.	LCS180618028BS
Tested by (name, function, signature)	Taylor Du (Engineer)
Check by (name, function, signature)	Eko Yang (Director)
Approved by (name, function, signature)	Jesse Liu (Manager)
Date of issue	June 29, 2018
Contents	13 pages
Testing laboratory	
Name	Shenzhen Southern LCS Compliance Testing Laboratory Ltd.
Address	B Area, 1-2F, Building B, Zhongyu Green High-tech Industrial Park, Wenge Road, Heshuikou, Gongming Street, Guangming New District, Shenzhen, China
Testing location	As above
Client	
Name	Berdis Lighting Co., Ltd
Address	6F, No2, DongHou Road, XinHui, JiangMen City, Guangdong Province, China
Manufacturer	
Name	Berdis Lighting Co., Ltd
Address	6F, No2, DongHou Road, XinHui, JiangMen City, Guangdong Province, China
Test specification	
Standard	Amendment A to AS/NZS 60598.2.2: 2016

Test procedure	Compliance with Amendment A to AS/NZS 60598.2.2: 2016
Non-standard test method	N/A
Test item Description	
LED Down Light	
Trademark	BERDIS
Model and/or type reference	B0103(BTD03), B0104(BTD04)
Rating(s)	200-240Vac,50Hz,9W

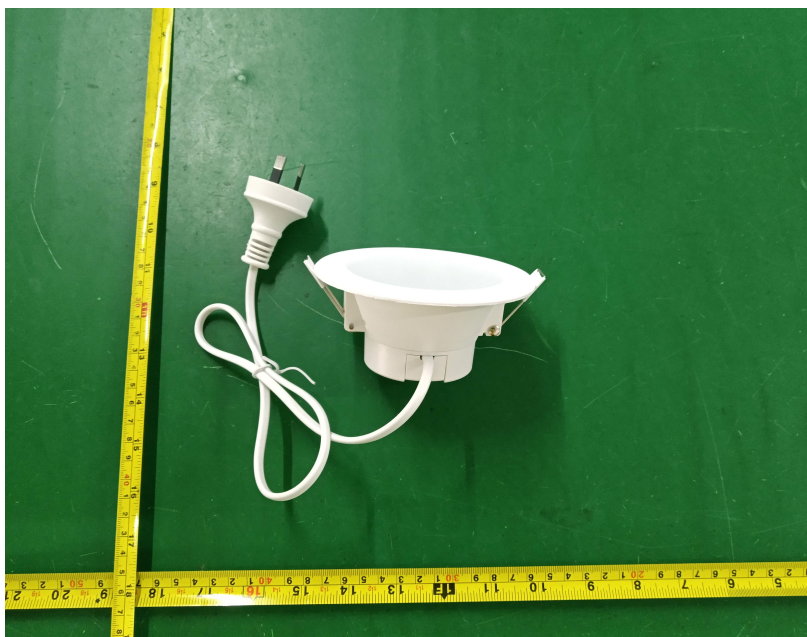
Figure 2

☐General
☐Front
☒Rear
☐Internal
☐Top
☐Bottom
☐PWB
